GLTMS/DEVB's Disclaimer: This presentation file is extracted from Webinar "Enhancing Biodiversity & Sustainability Through Systematic Management of Pioneer Tree Species" held by GLTMS/DEVB on 16.1.2025:

Phased Replacement of Senescent *Acacia confusa* and *Peltophorum pterocarpum* at Yuen Chau Kok, Sha Tin

Landscape Division / HYD

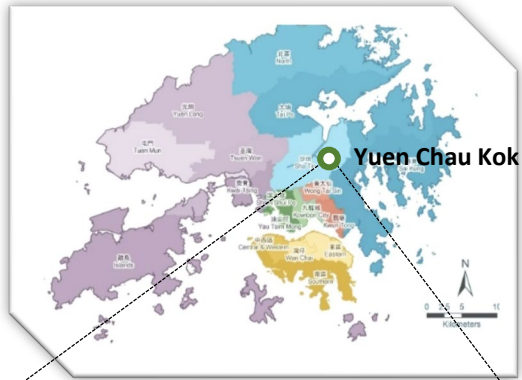
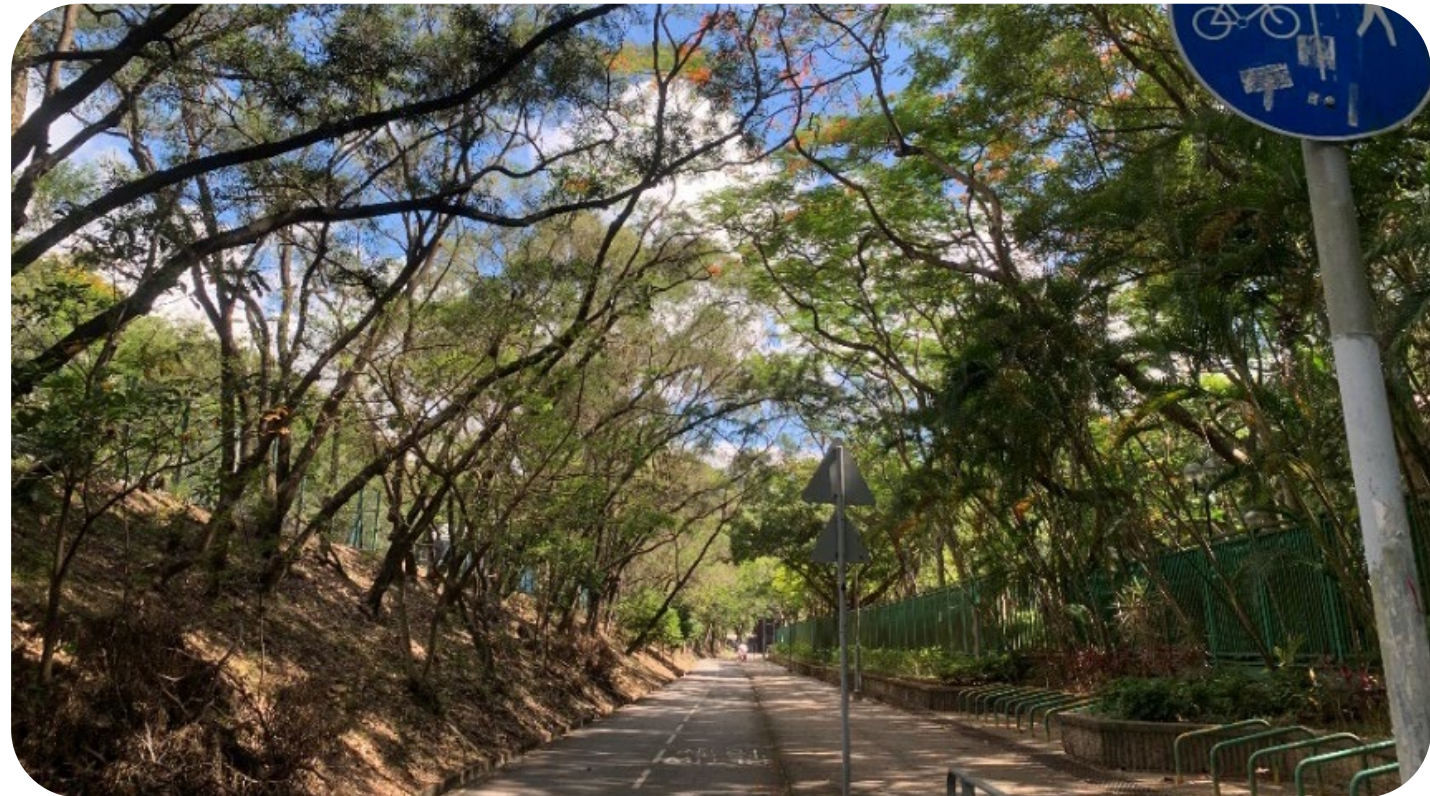
- Dominant trees species in Yuen Chau Kok
 - *Peltophorum pterocarpum* (盾柱木)
 - *Acacia confusa* (台灣相思)
- Most of the tree forms are *imbalanced*
- Most of the trees are *leaning* toward the pathway and cycle track, *imposing potential dangers* to the pedestrians and the cyclists

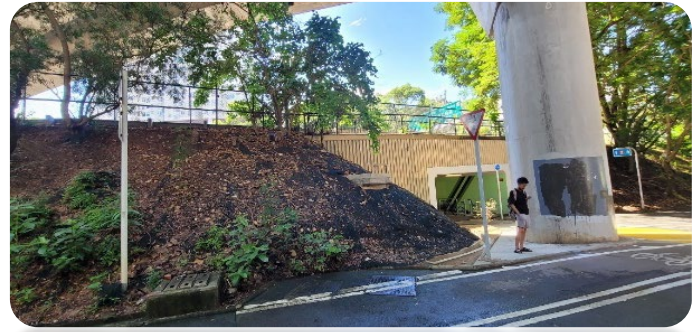
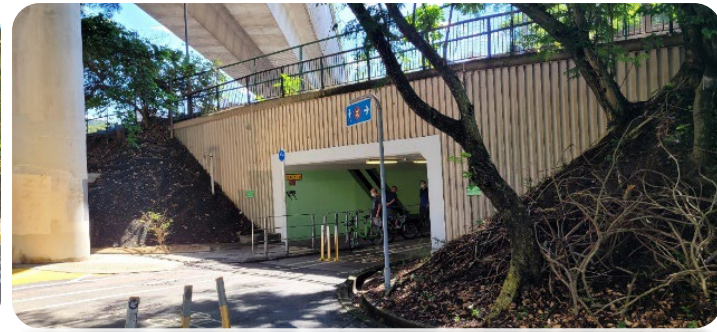
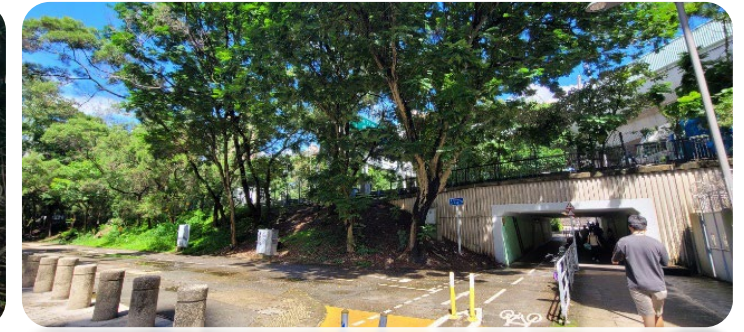
2021 Replacement Scheme (Phase 1)

Feature Planting Species

Native trees with
conspicuous flowers

Reevesia thyrsoidea
梭羅樹

Camellia japonica
山茶

Shrubs with flowering
and seasonal changes

Gardenia jasminoides
梔子

Lespedeza formosa
美麗胡枝子

Hemerocallis fulva
萱草

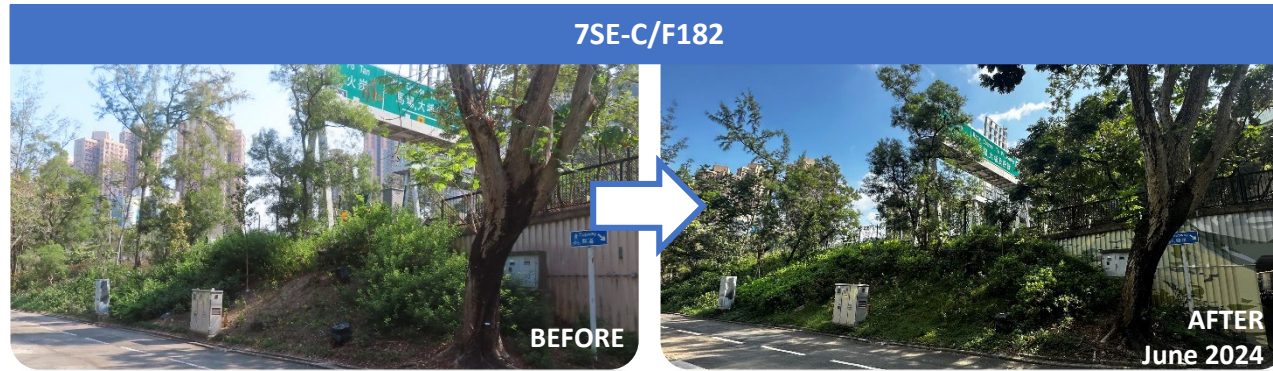
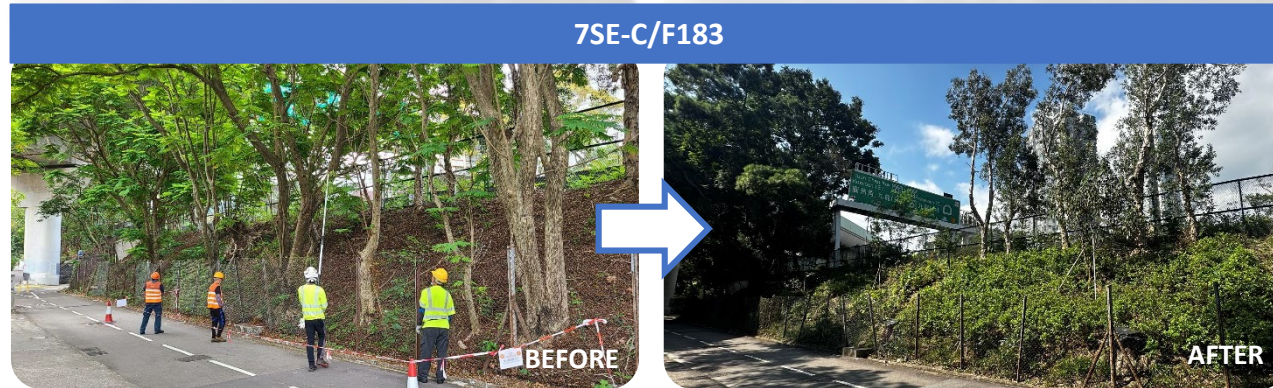
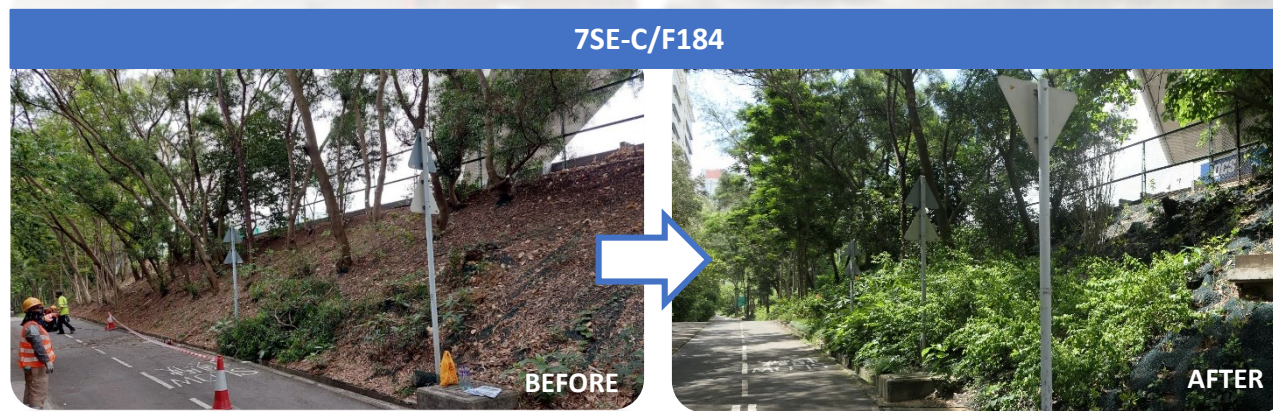
COMPLETION PHOTOS – PHASE 1

Improvements at Subway Entrances

- Remove aging trees identified as posing risks
- Introduce conspicuous flowers to highlight the subway entrances
- Restore understory vegetation

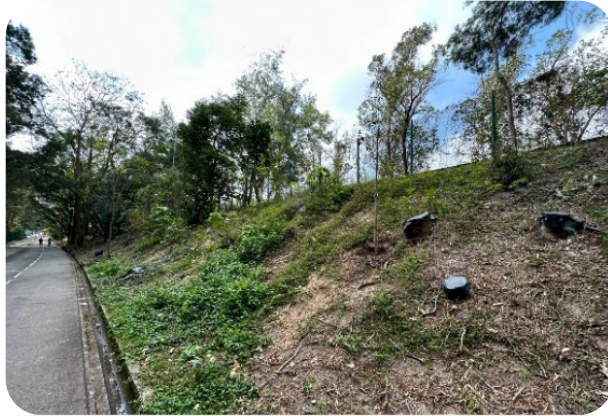
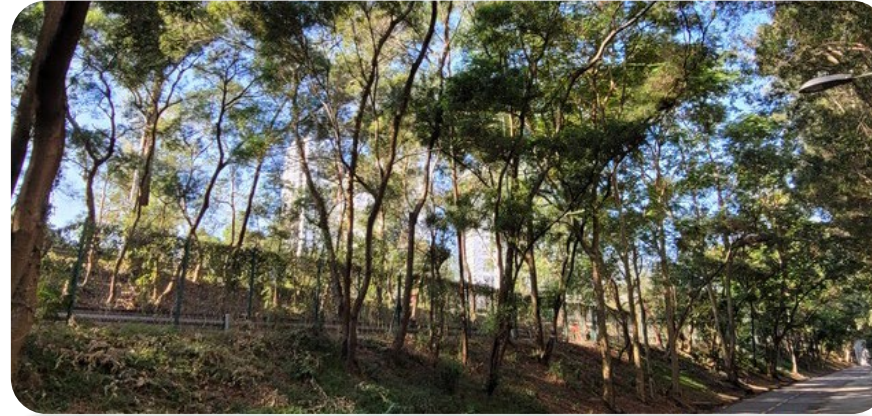
Replacement Scheme (Phase 2)

Feature Planting Species

Native trees with vibrant foliage

Sterculia lanceolata
假蘋婆

Machilus chekiangensis
浙江潤楠

Shrubs with flowering and seasonal changes

Rhaphiolepis indica
車輪梅

Psychotria asiatica
九節

Rhodomyrtus tomentosa
桃金娘

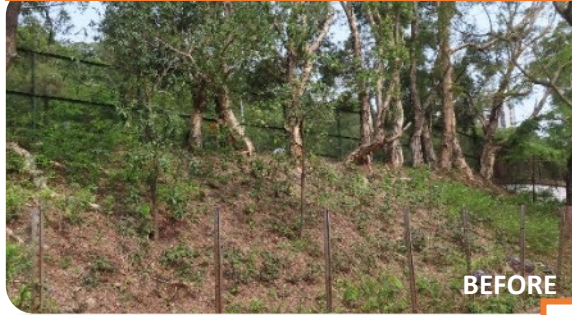
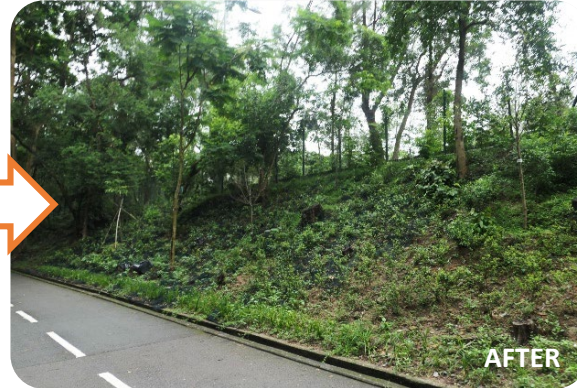
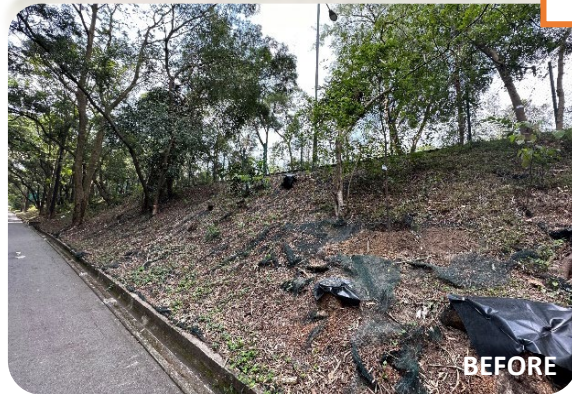
7SE-C/F183

Slopes with higher priority

- Remove aging trees identified as posing risks
- Replanting native trees and shrubs with high ecological value and seasonal changes
- Restore understory vegetation

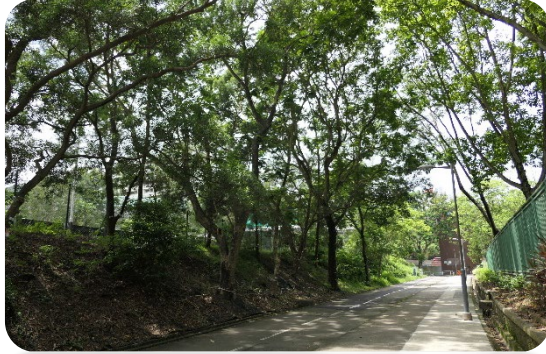
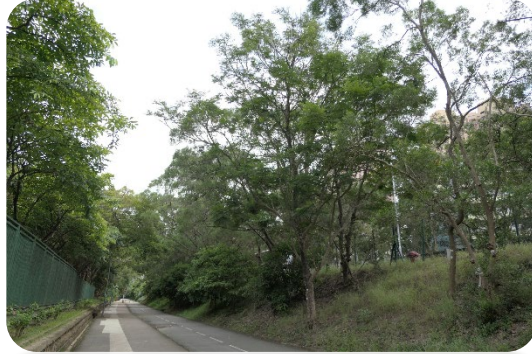
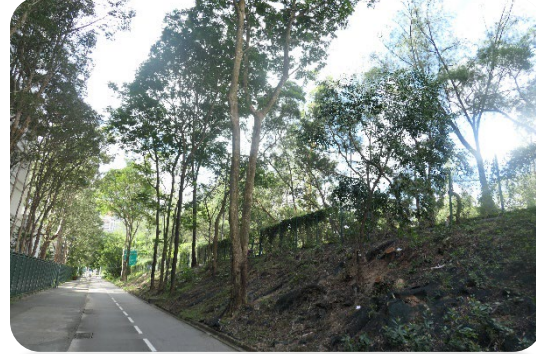
2023 Replacement Scheme (Phase 3)

Feature Planting Species

Native trees with
ecological value

Ilex rotunda Thunb
小果鐵冬青

Viburnum odoratissimum
珊瑚樹

Ixora chinensis Lam.
龍船花

Pennisetum alopecuroides
狼尾草

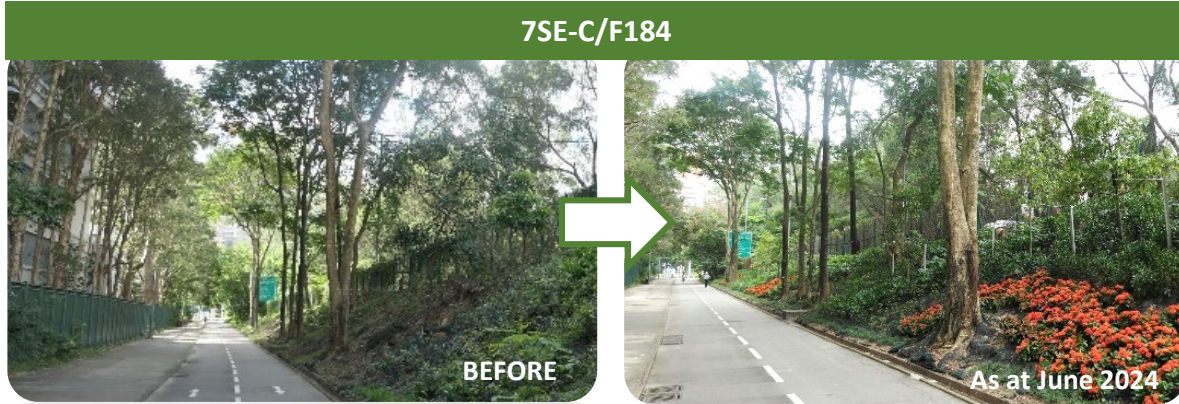
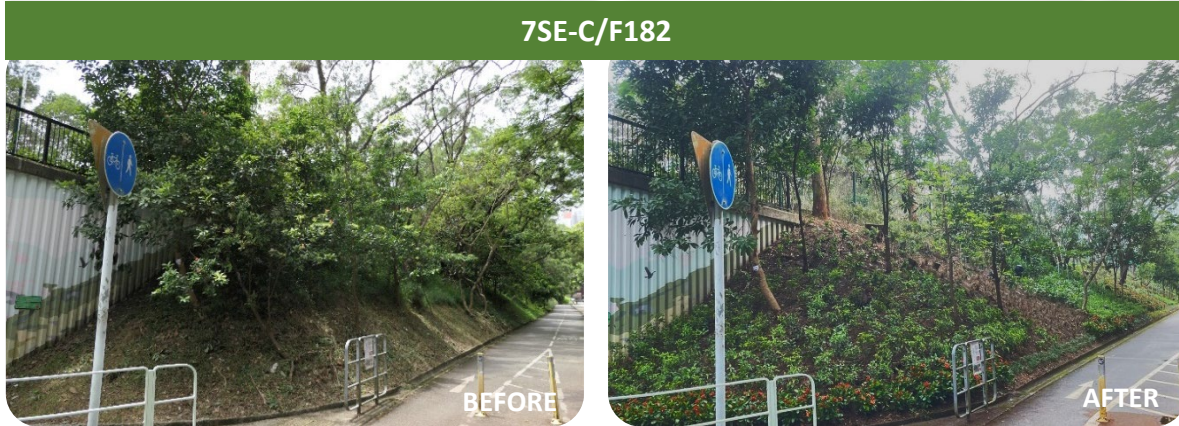
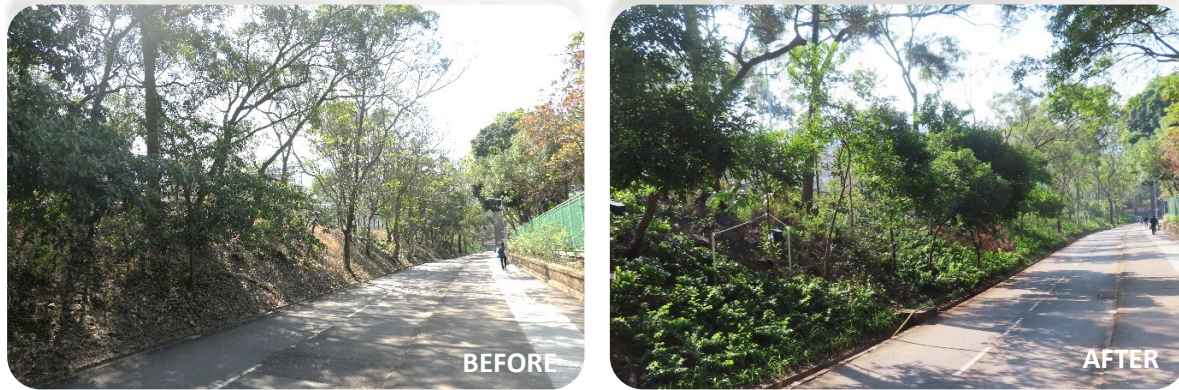
COMPLETION PHOTOS – PHASE 3

Slopes with lower priority

- Remove aging trees identified as posing risks
- Replanting native trees and shrubs with high ecological value and seasonal changes
- Restore understory vegetation
- Introduce plants with higher amenity value

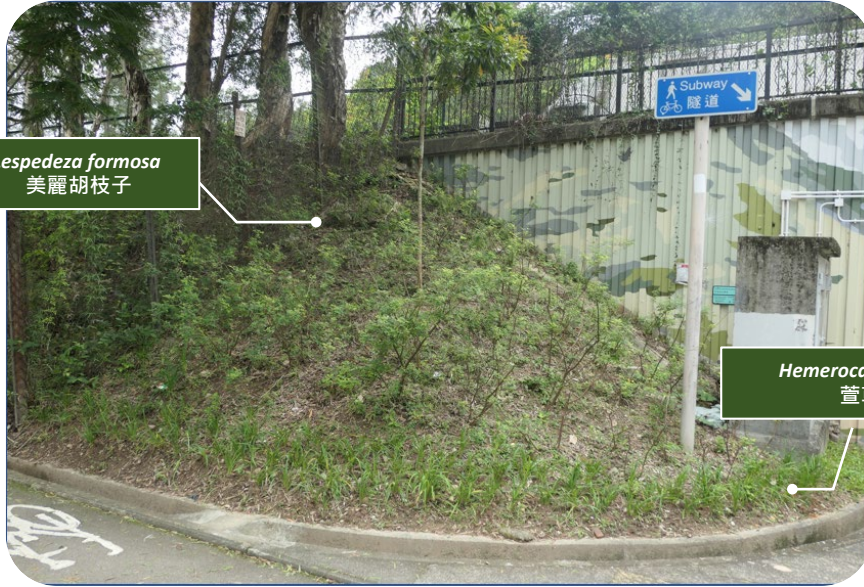
J
U
N
2
0
2
4

Maintenance mode

- Planting works were completed in June 2023
- Standard landscape maintenance were adopted to the slopes during the Establishment Period
- Establishment Period was completed in June 2024
- The slope was handed over to the HyD M&M Term Contractor for maintenance in July 2024, with standard landscape maintenance works scheduled every 6 months

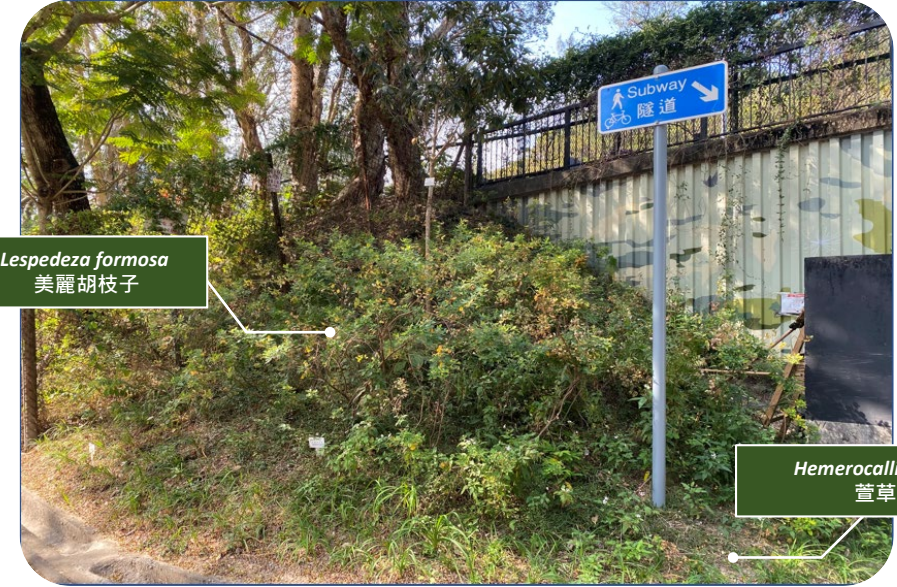
J
A
N
2
0
2
5

Observation

- Maintained under HyD M&M Term contractor for 7 months
- The slope is about 35°
- Understory vegetation is observed to be covered by weeds
- *Lespedeza formosa* has been observed to perform particularly well under low maintenance conditions; however, attention has to be paid to the problem of overgrowth.

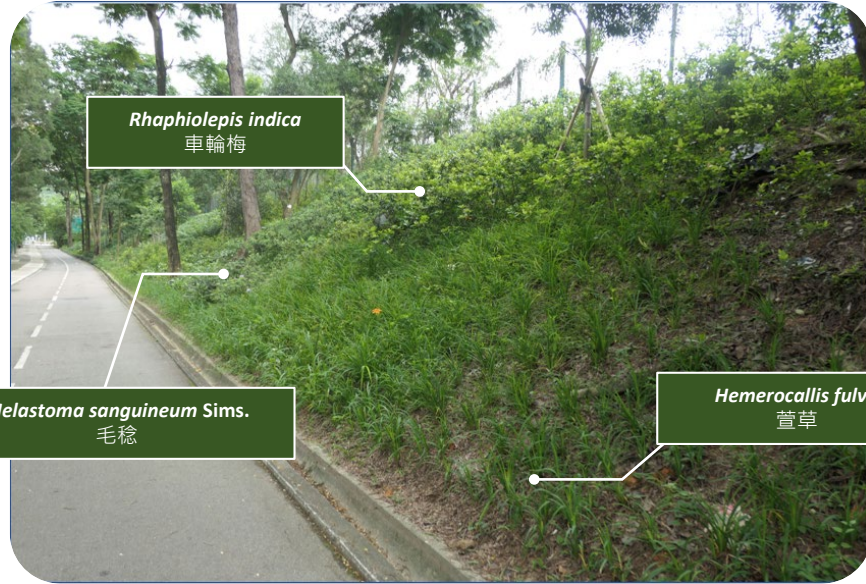
J
U
N
2
0
2
4

Maintenance mode

- Planting works were completed in October 2022
- Standard landscape maintenance were adopted to the slopes during the Establishment Period
- Establishment Period was completed in June 2024
- The slope was handed over to the HyD M&M Term Contractor for maintenance in July 2024, with standard landscape maintenance works scheduled every 6 months

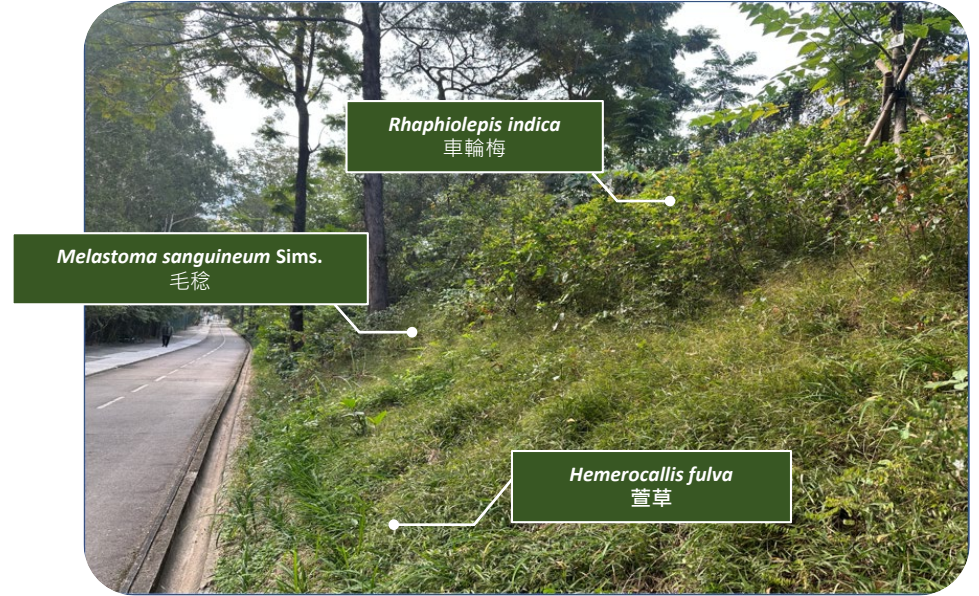
J
A
N
2
0
2
5

Observation

- Maintained under HyD M&M Term contractor for 7 months
- The slope is about 35°
- Understory vegetation is observed to be covered by weeds
- *Rhaphiolepis indica* has been noted to perform well in low-maintenance conditions, on high gradients slope, and in partially shaded environments.

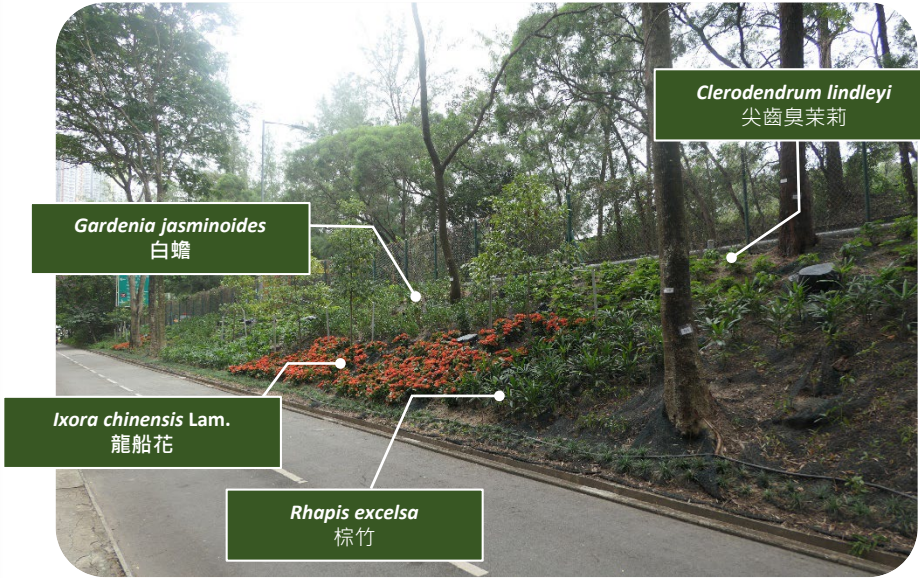
Maintenance mode

- Planting works completed on December 2023
- Standard landscape maintenance were adopted to the slopes during the Establishment Period
- Establishment Period completed on December 2024
- The slope will be handed over to the HyD M&M Term Contractor for maintenance in February 2025, with standard landscape maintenance works scheduled every 6 months

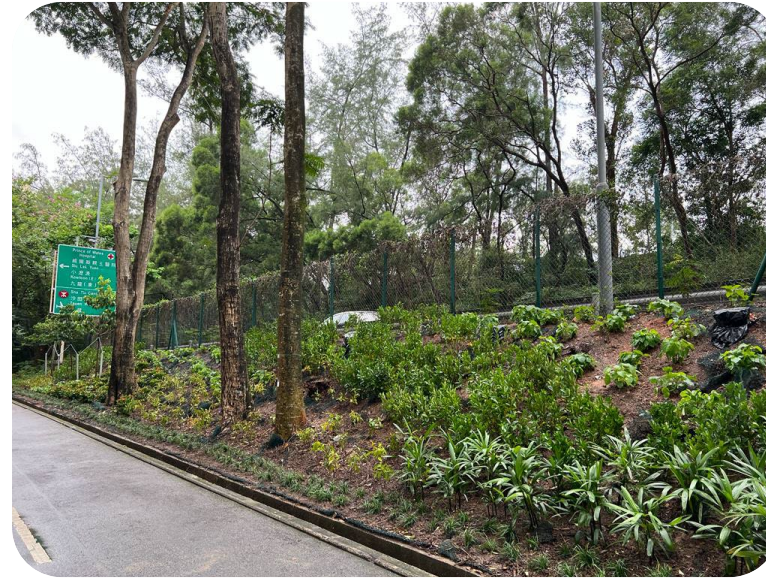
Observation

- The slope is about 35°
- More intensive watering is required to ensure the plants at the top of the slope establish well
- The overall planting performance under regular landscape maintenance is satisfactory

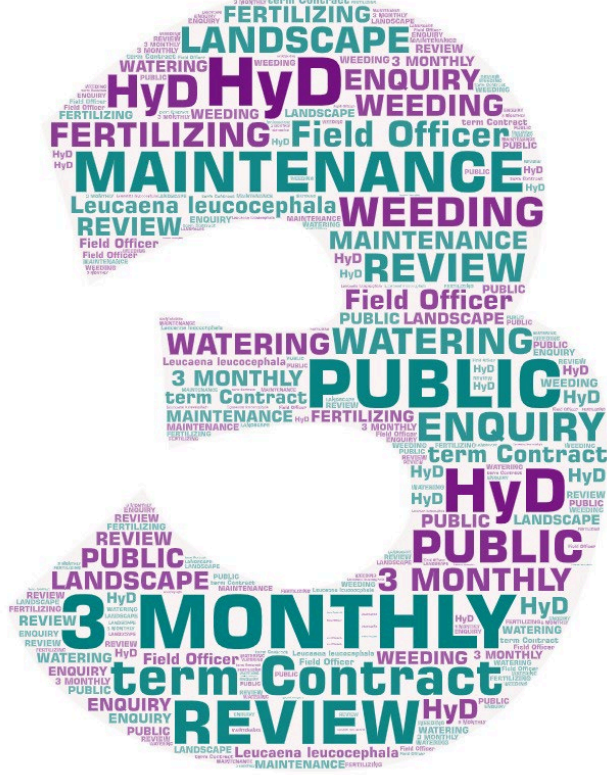
Monthly Inspection

On slopes with public enquiry:
Monthly inspection + Landscape
maintenance operation in 3
monthly basis when necessary
